**ABU GHRAIB DAIRY
ABU GHRAIB, IRAQ**

**SIGIR PA-09-172
JANUARY 14, 2009**

Abu Ghraib Dairy

Summary of Report: PA-09-172

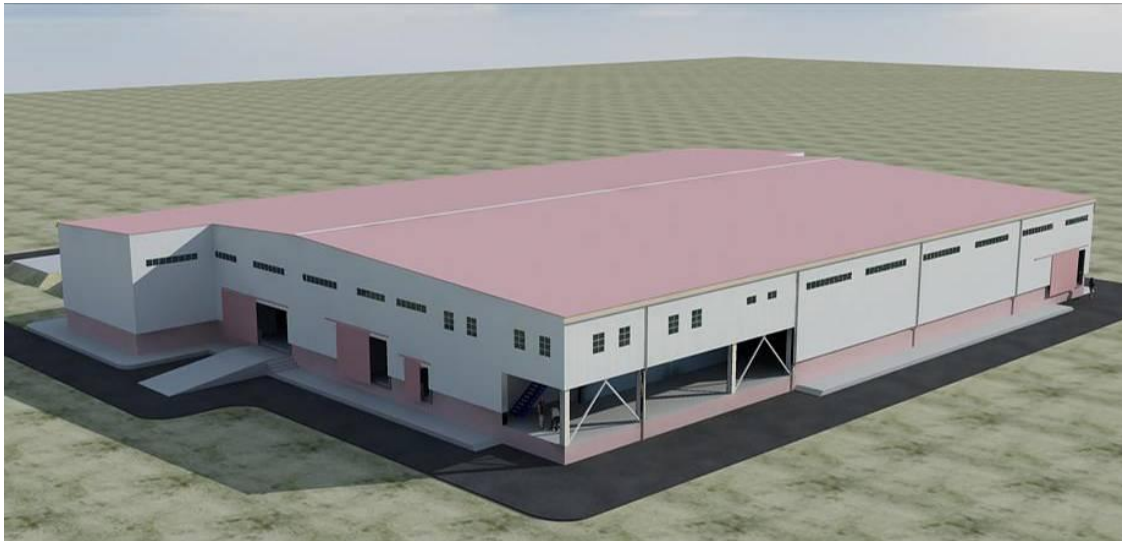
The contractor designed the construction of an approximately 2,900 square meter facility (Figure 1), including water and fuel storage tanks. The contractor provided detailed architectural plans for the project, including exterior renderings of the facility, exterior elevations, several interior cross sections, and floor plan information regarding building layout and room dimensions.

Figure 1. Rendering of dairy building and surrounding area (Courtesy of TFBSO)

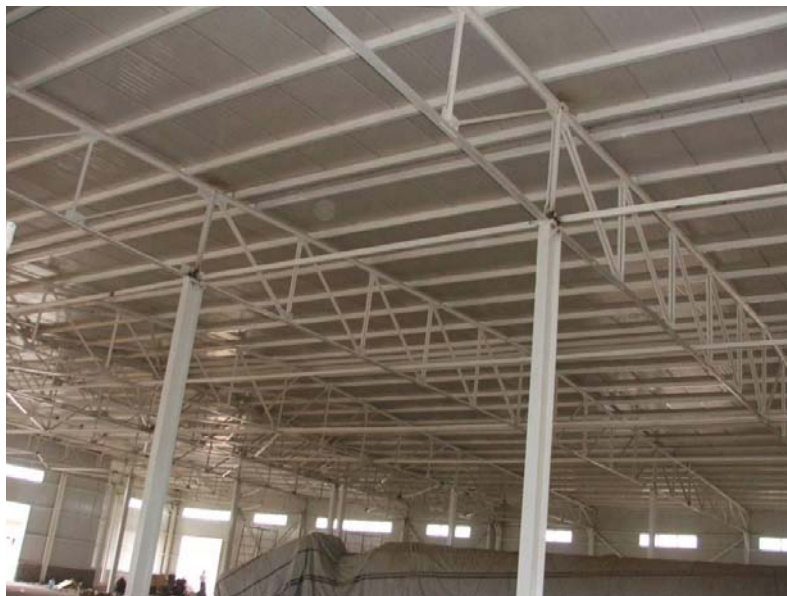
At the time of the site visit, all structural steel, with the exception of the mezzanine, had been erected. The steel structure for the dairy building consisted of continuous steel trusses supported by steel columns (Site Photo 6). The trusses at the ends of the structure and at either side of the expansion joints were braced with diagonal bracing in the plane of the upper and lower chord. The trusses are also braced transversely in the plane of the lower chord with steel braces running the length of the structure.

Site Photo 6. Lateral brace connection at column cap plate

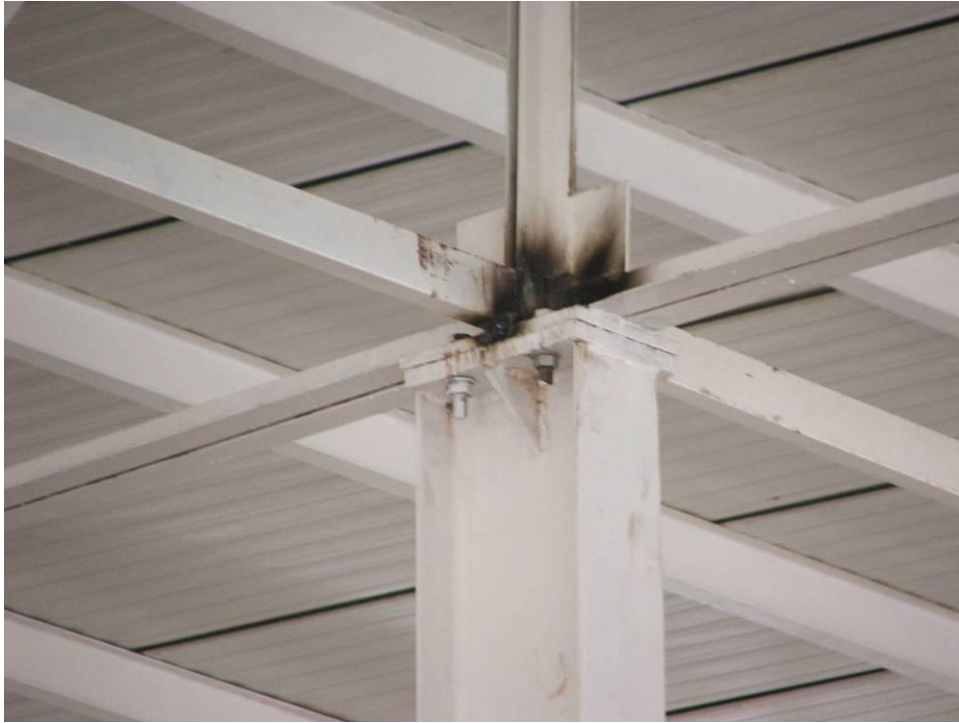
Lower bracing was welded to the column cap plate (Site Photo 9), which acts to resist lateral sway at the top of the column. Since the truss is continuous, loads from the roof will induce compressive stress in the bottom chord above the column. The compressive stress could produce buckling in the lower chord. The connection between the truss and the column is effectively a hinge point, and the lateral bracing is essential to resist this buckling and prevent movement of the column.

Site Photo 9. Lateral brace connection at column cap plate

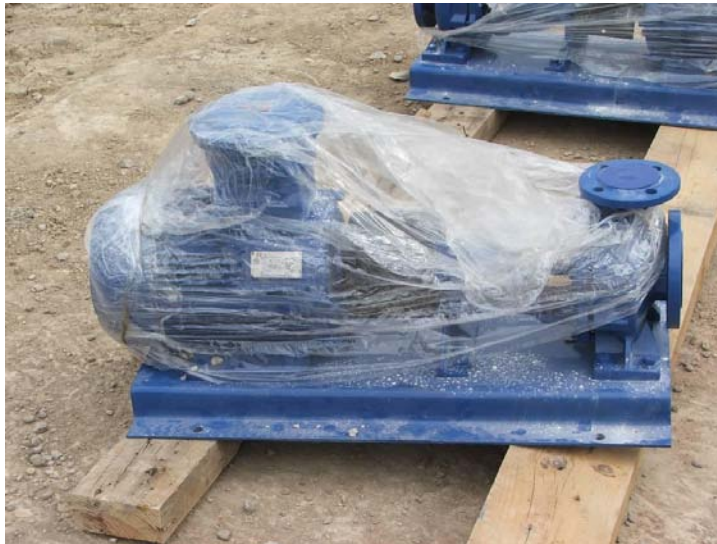
Pumps were on site awaiting installation (Site Photo 14). According to the contractor, they are fuel oil transfer pumps, which will be placed in the pump vault²² between the two fuel oil tanks.

Site Photo 14. Pumps for fuel oil transfer

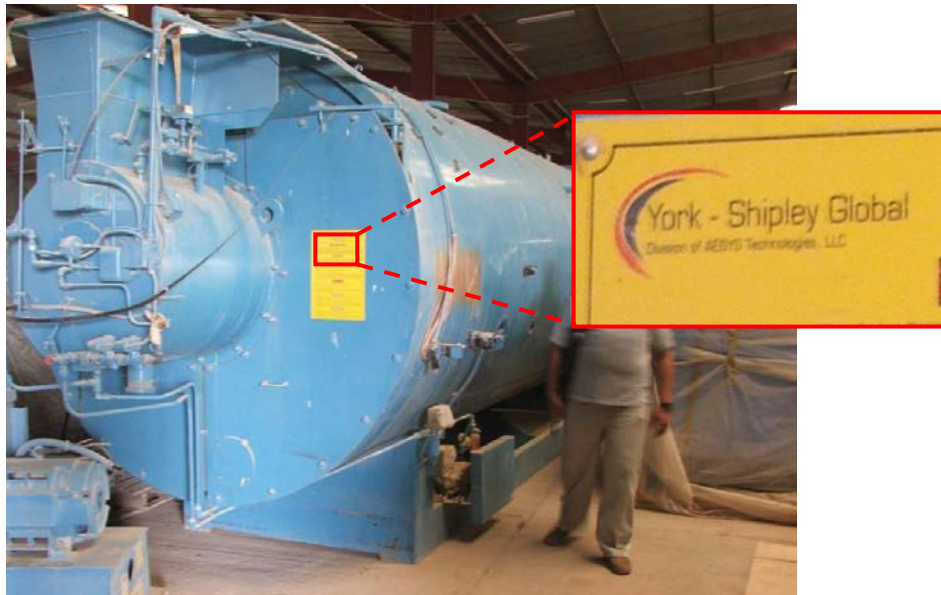
With the exception of one large piece of equipment already located inside the newly constructed facility, the milk processing and packaging equipment is stored inside a leaking warehouse²³ near the Abu Ghraib Dairy (on the Ministry of Industry and Minerals compound). SIGIR toured the warehouse and found most of the equipment in its original packaging and appeared to be in good condition. One of the pieces of equipment sustained some damage due to either improper storage or handling (Site Photo 16). SIGIR was able to identify several pieces of equipment with visible nameplates (Site Photo 17), and the remainder of the equipment was labeled with shipping labels.

Site Photo 17. Dairy production equipment

²³ It had recently rained and SIGIR observed a noticeable amount of water on the floor and on the equipment.
